Bulletin No:Parts 2013 – DR1152Date:31st July 2013Audience:Parts Managers, Collision IndustrySubject:Cam Sensor Fault Code after Collision Repair to Holden Cruze

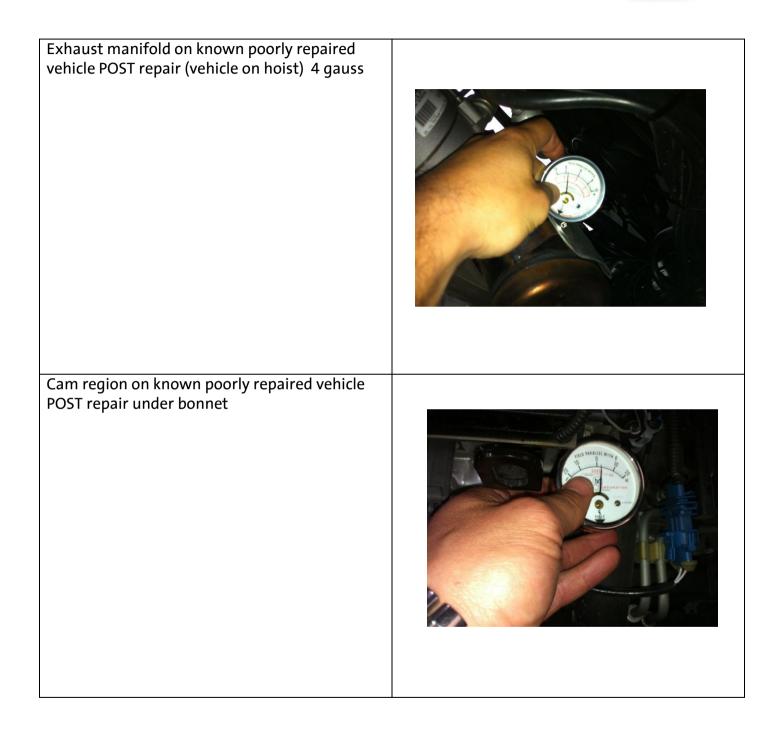
- The fault has not been present before the collision repair took place.
- The fault may be continuous or intermittent after the collision repair has been completed.
- When inspected by a Holden authorised dealer, the cam sensor fault cannot be cleared even after replacement of associated parts.
- A magnetic field of more than 2 Gauss in the region of the cam sensor can be detected by a calibrated Gauss meter, and as high as 4 Gauss on associated parts like exhaust manifolds (normally both < 0.5 Gauss). Refer to pics attached below.

Please see images below for further clarification:
