Sectioning A Part In The Same Location Twice

I-CAR and subject matter experts from vehicle makers, collision repairers, insurers, and tool and equipment makers held a meeting in May, to develop, update, and publish an I-CAR best practice on Sectioning A Part In The Same Location Twice.

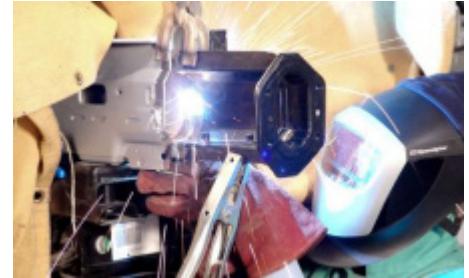
If a previous sectioning joint has been completed at a specific location, that joint location is no longer a viable option for a second sectioning joint. The next available OEM procedure should be selected to complete the repair.

The main focus of this Best Practice applies to front and rear rails and reinforcements, however, this also applies to the outer uniside. On an outer uniside, there are often ranges given that would allow a second sectioning joint in the same area general area; just not in the exact same location(s), with consideration given to backing size, if required, for the joint. If the backings would be touching or if the repair joint would have to be made outside of the section range, the next available OEM procedure should be selected to complete the repair.
