2016 Civic: New Model Body Repair Information

DISCLAIMER: This publication contains a summary of new body and vehicle technology that may affect collision and other body repairs. Always refer to the appropriate electronic service information for complete repair information. A subscription may be purchased at: techinfo.honda.com

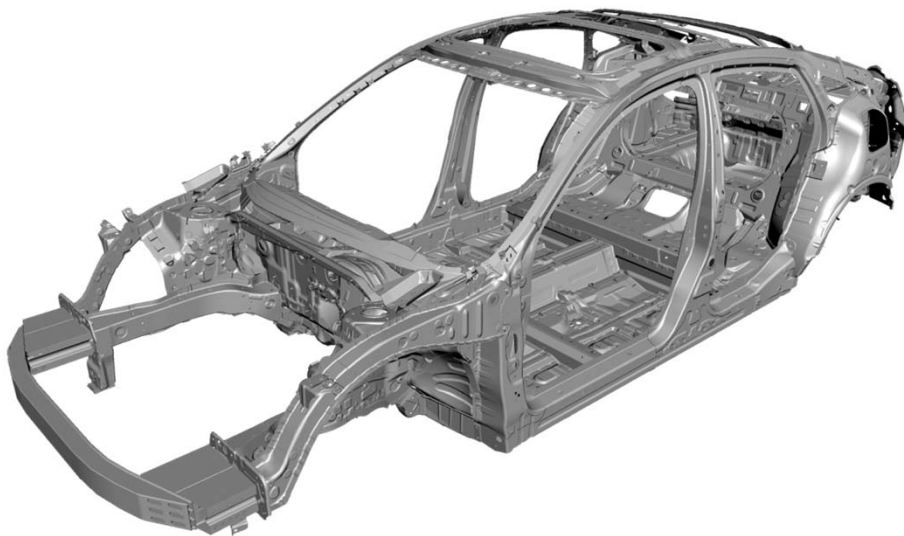
- Next-Generation Advanced Compatibility Engineering™ (ACE™) body structure
- Body construction using 58% high-tensile-strength steel (HSS), including 26% ultra-high-strength steel (UHSS - 980 MPa and higher)
- Weight-saving 1,500 MPa steel center pillar stiffener and rear frame with soft zones for crash performance
- Bolt-on resin composite lower front bulkhead assembly
- Introduction of the Honda Sensing™ suite of advanced safety and driver-assistive technologies, including: Adaptive Cruise Control with Low Speed Follow, Lane Keeping Assist System, Road Departure Mitigation, and Collision Mitigation Braking System™ with pedestrian sensing capability

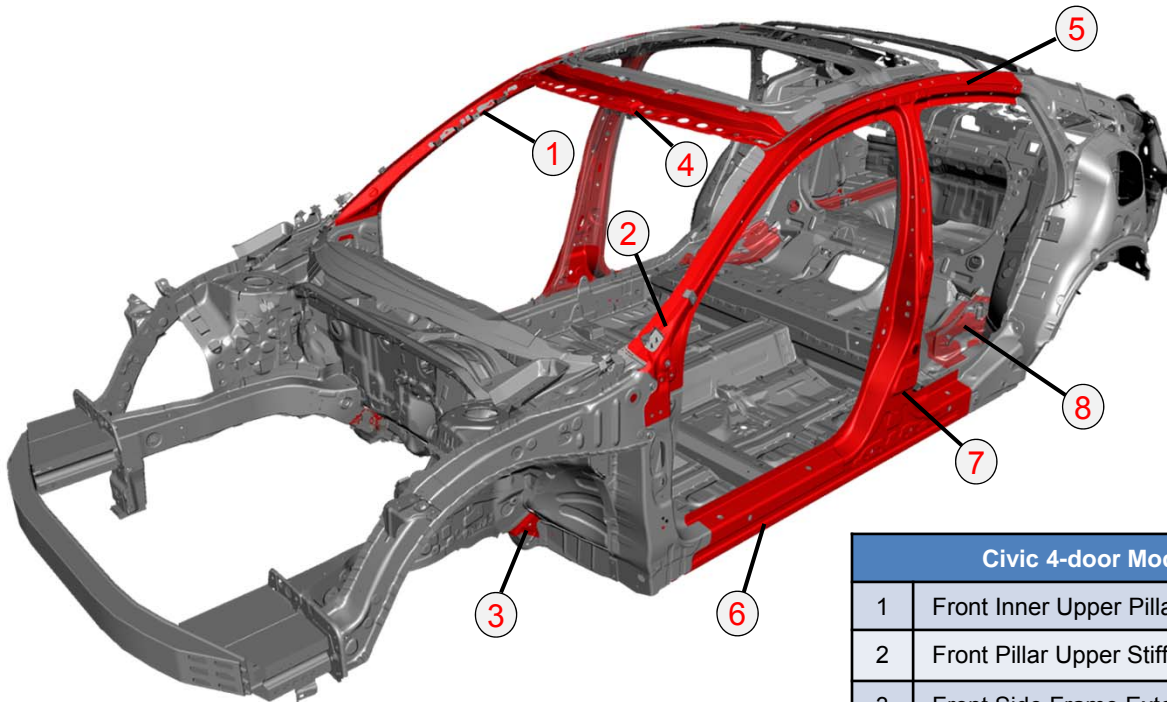
The numbered parts in the diagram below are constructed of 1,500 MPa steel:

Civic 4-door Models	
1	Front Inner Upper Pillar
2	Front Pillar Upper Stiffener
3	Front Side Frame Extension
4	Roof Front Rail
5	Roof Side Stiffener
6	Side Sill Reinforcement
7	Center Pillar Stiffener
8	Rear Frame

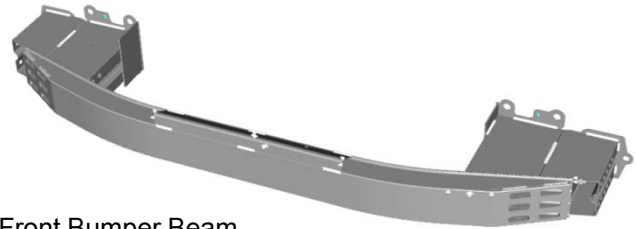
The front bumper beam uses 6000 series aluminum alloy construction.

- Do not repair damaged bumper beams.
- To help prevent galvanic corrosion, some fasteners for aluminum parts are considered one-time use and must be replaced if removed.

Front Bumper Beam

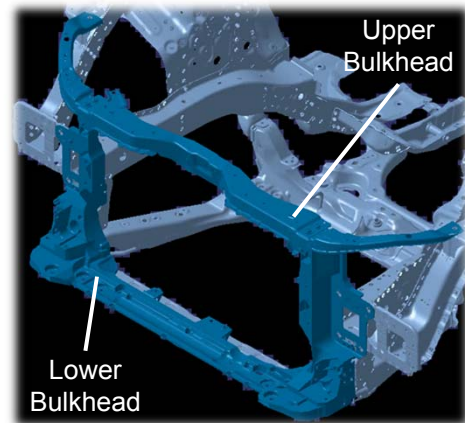
This vehicle has a lower bulkhead assembly constructed of resin composite material.

- The upper bulkhead frame is constructed of 270 MPa mild steel.
- The front upper and lower bulkheads are only sold as a complete assembly.
- The bulkhead design improves engine compartment access during factory assembly and service.
- The cooling fans, radiator, A/C condenser, hood lock, outside air temperature sensor, and related piping/components are attached to the front bulkhead.
- The bulkhead is attached to the body with 20 bolts.
- A damaged bulkhead must be replaced.
- For more information, refer to “Front Bulkhead Replacement” in the body service information.

Resin Composite Front Bulkhead

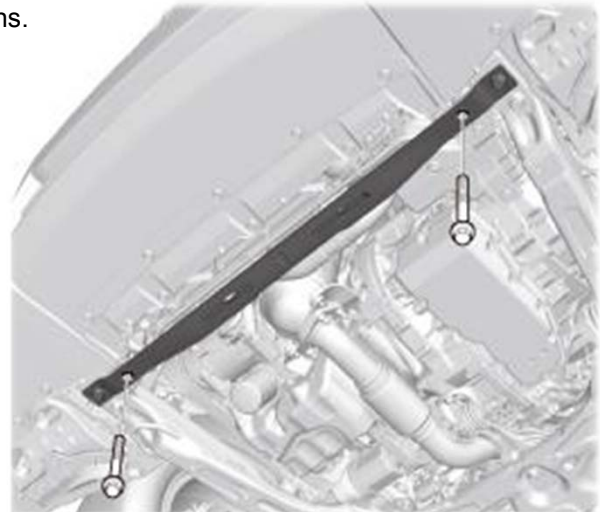
This front brace is located under the front bumper directly ahead of the front subframe.

- The front brace is attached to the body using special collar bolts that compensate for body dimensional variations.
- A special removal and installation procedure is required
- For more information, refer to “Front Brace Removal and Installation” in the service information.

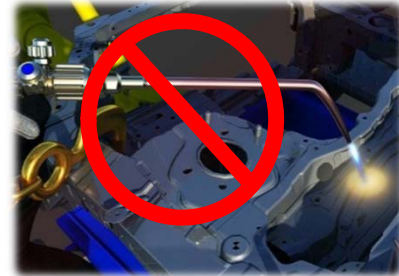
- **Do not** apply heat to any body part during straightening. This may compromise the internal structure and strength of high-strength steel parts.
- Any part that has heat applied to it during straightening **must** be replaced with new parts.
- Ignoring these instructions may significantly reduce occupant protection in any subsequent collision.

Do not heat during straightening

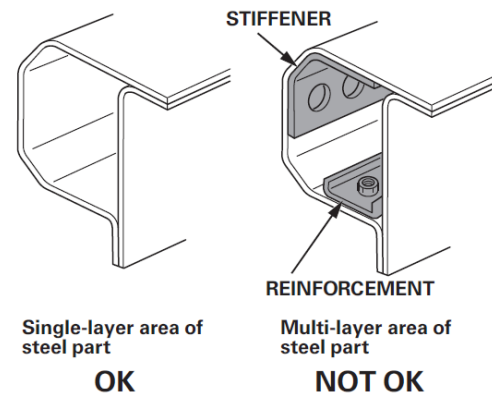
- Sectioning (cut and joint) should usually be avoided except for mild steel outer panels and floor panels unless a specific procedure is provided in the body service information.
- However, depending on the type of vehicle damage, steel parts with a tensile strength ≤ 780 MPa may be sectioned provided **all** of the following conditions are met:
 - Sectioning must be done in a single-layer area of the part.
 - Multi-layer internal steel reinforcements and stiffeners must not be cut.
 - The repair is not in a load-bearing area such as engine, transmission, or suspension mounting points.
- Replace body structural components such as stiffeners, reinforcements, and other multi-layered steel parts as assemblies that match the replacement parts configuration.
- Approved welding methods are listed in the table on the right.
- Refer to the body service information for complete information.

Sectioning Area Examples

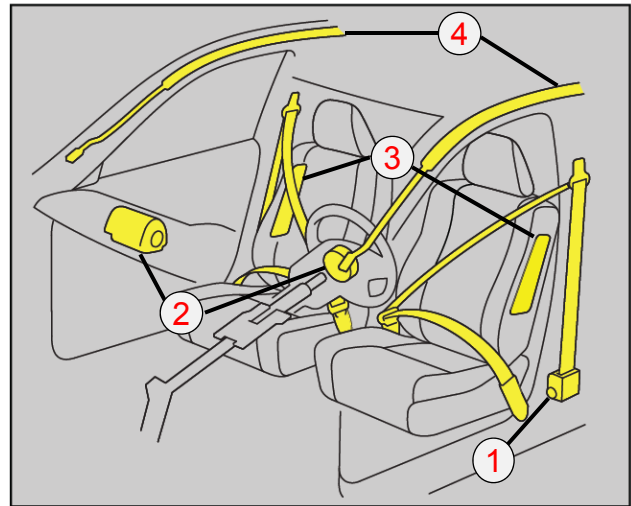
1. Driver's and front passenger's seat belt tensioners (may deploy independently from any airbags).
2. Driver's and front passenger's SRS airbags.
3. Side airbags mounted in the driver's and front passenger's outer seat-backs.
4. Side curtain airbags mounted above the left and right side windows under the headliner.

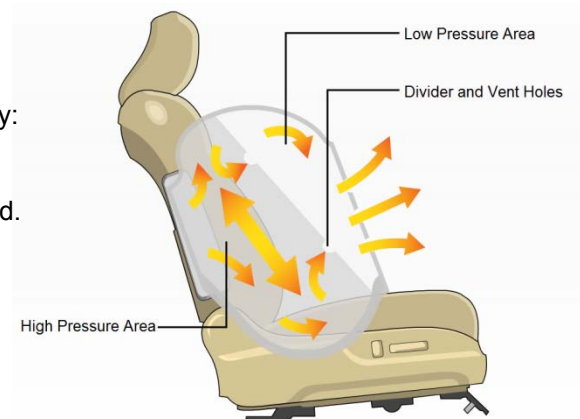
- This airbag design helps mitigate the risk of excessive airbag deployment force and risk of injury to smaller seat occupants.
- It eliminates the need for the occupant position detection system (OPDS) sensor located in the front passenger's seat-back.

- Special seat covers and/or breakaway thread are used to ensure the proper deployment path.
- Damaged front seat covers should be replaced, not repaired.
- Do not install non-factory seat covers; they may alter the airbag's intended deployment path.

SmartVent Side Airbag

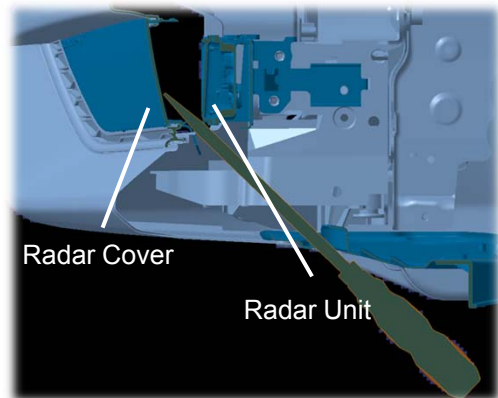
Some models are equipped with Adaptive Cruise Control and a Collision Mitigation Braking System™ (CMBS™). These systems use a millimeter wave radar unit mounted behind a plastic cover on the lower left side of the front bumper.

- This radar unit senses through a plastic cover attached to the left front fog light trim using hook-style clips.
- This part is specially designed to prevent radar interference.
- Do not paint or install any coverings over the radar cover. This may cause the Collision mitigation braking system indicator to come on and DTC P2583-97 (dust or dirt on the millimeter wave radar) to set.
- Radar cover removal requires a specific procedure and can be difficult. Refer to “Millimeter Wave Radar - Vertical Radar Aim” in the service information.

Side Cutaway View - Left Front Bumper Area

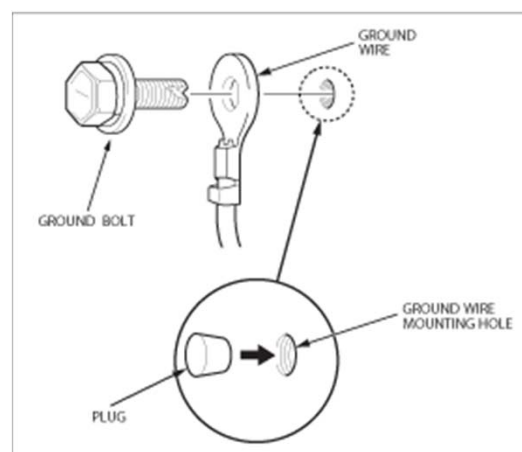
- Painting over electrical ground locations may cause electrical systems, such as vehicle stability assist (VSA), to malfunction and set DTCs that may be difficult to diagnose.
- Protect the ground wire with masking tape and the ground wire mounting hole threads with a bolt or silicone plug when priming or painting.
- Honda ground bolts are almost always non-anodized, zinc plated self-cutting bolts. They can be identified by the triangular notch in the threads. Using the wrong bolt can cause ground problems.
- Do not use star or burred washers on electrical grounds.
